Harvard University - McKinlock Hall
TYPE: AE08

Project: Harvard University - McKinlock Hall

Harvard University - McKinlock Hall
TYPE: AE08 Damage Report; Arm #3

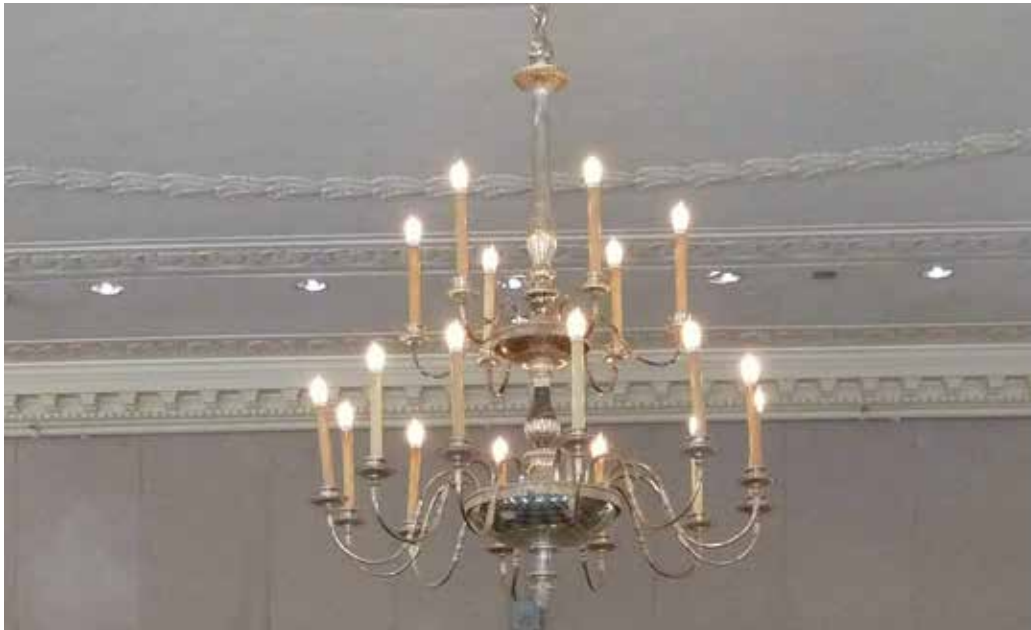
- 1st Floor - Dining room
- Two tier 18 light traditional holders with metal accent

- Arm #3 has two previous holes drilled on the top portion.
- Arm #9 has three previously drilled holes on the top and one on the bottom.
- Arm # 12 has one crack under the bobache.
- This damage will not be repaired as it can cause further damage to the arm and ruin the existing plating. A protective sleeve will be added on wire to protect it and drilled holes will be smoothed to prevent future damage to internal wiring.

- Existing fixture shall be disassembled and hand polished to reveal original silver finish. This includes removal of the existing lacquer, cleaning, hand polishing and application of UV Resistant clear high gloss lacquer.
- Sample reviewed and approved during site 9/20 meeting.
- Replace all missing decorative and mechanical components.
- Repair all mechanical defects.
- Replace and rewire all electrical components with UL listed products and test in accordance with UL standards. Medium base sockets to be utilized.

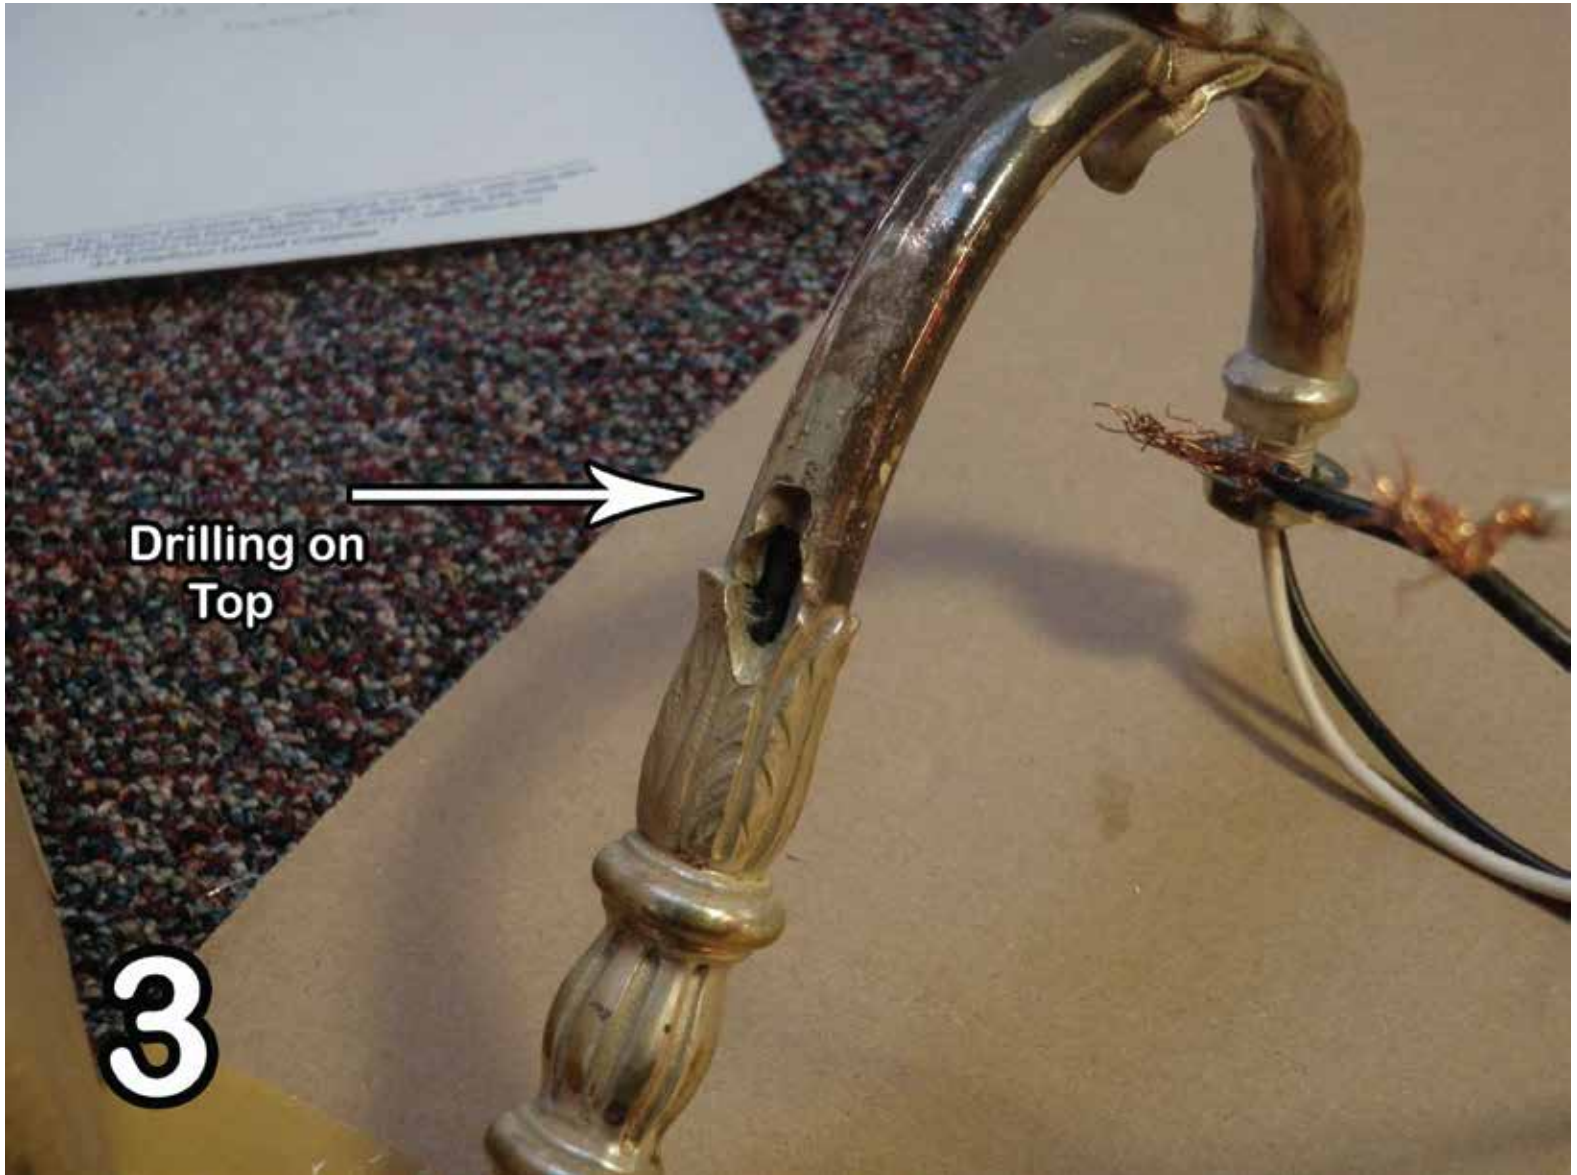
3

Drilling on
Top

- Arm #3 has two previous holes drilled on the top portion.
- This damage will not be repaired as it can cause further damage to the arm and the plating. A protective sleeve will be added on wire to protect it.

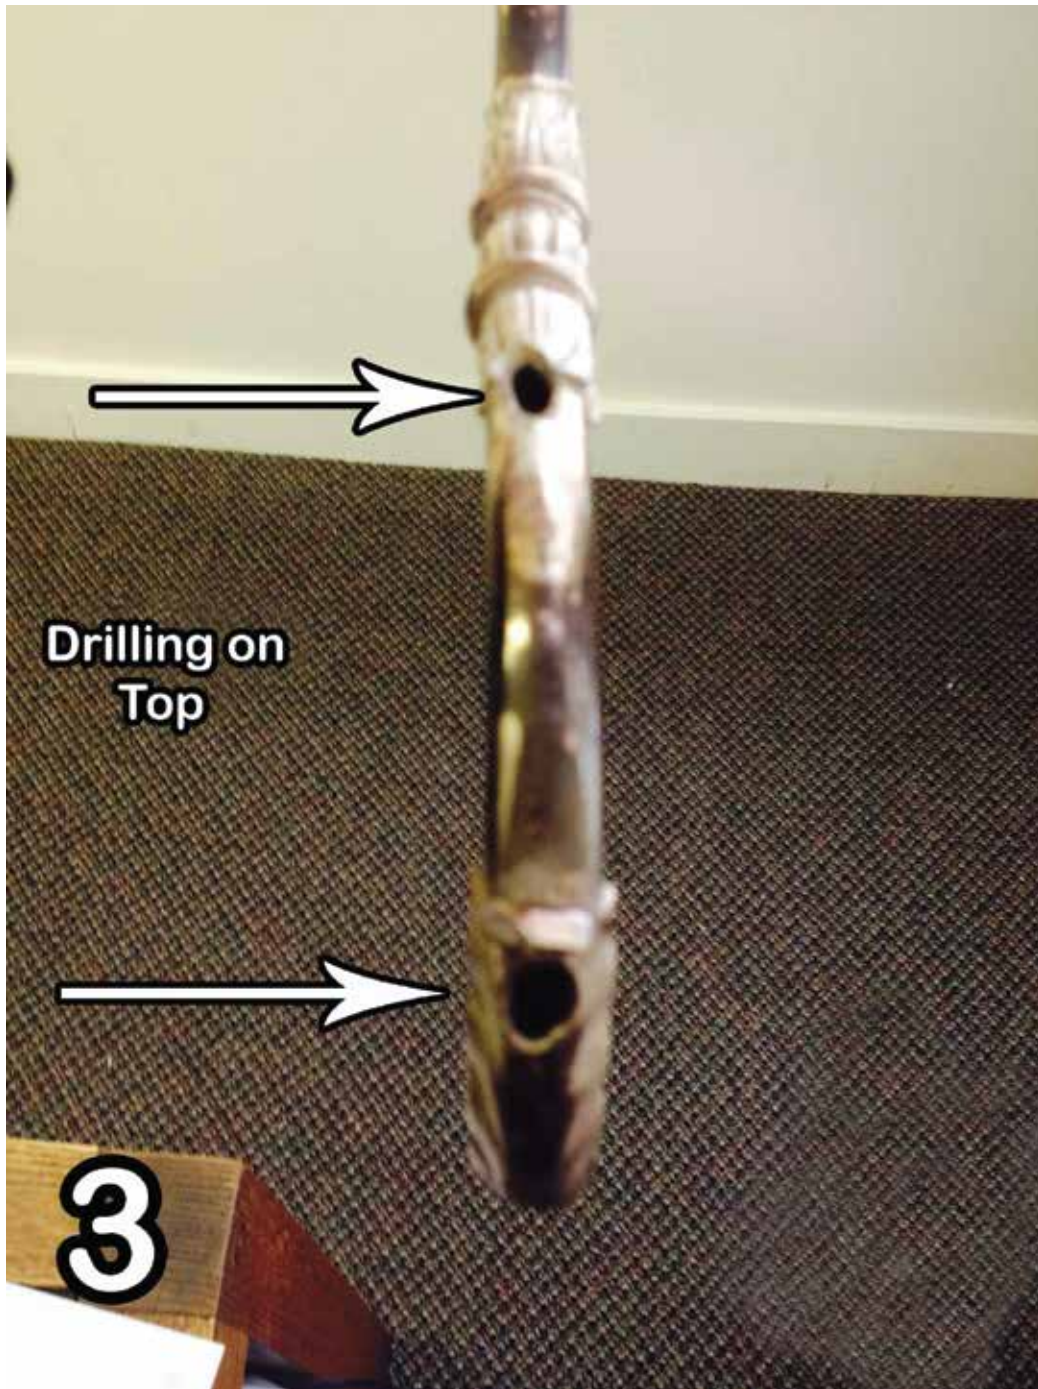
3

Drilling on
Top

- Arm #3 has two previous holes drilled on the top portion.
- This damage will not be repaired as it can cause further damage to the arm and the plating. A protective sleeve will be added on wire to protect it.

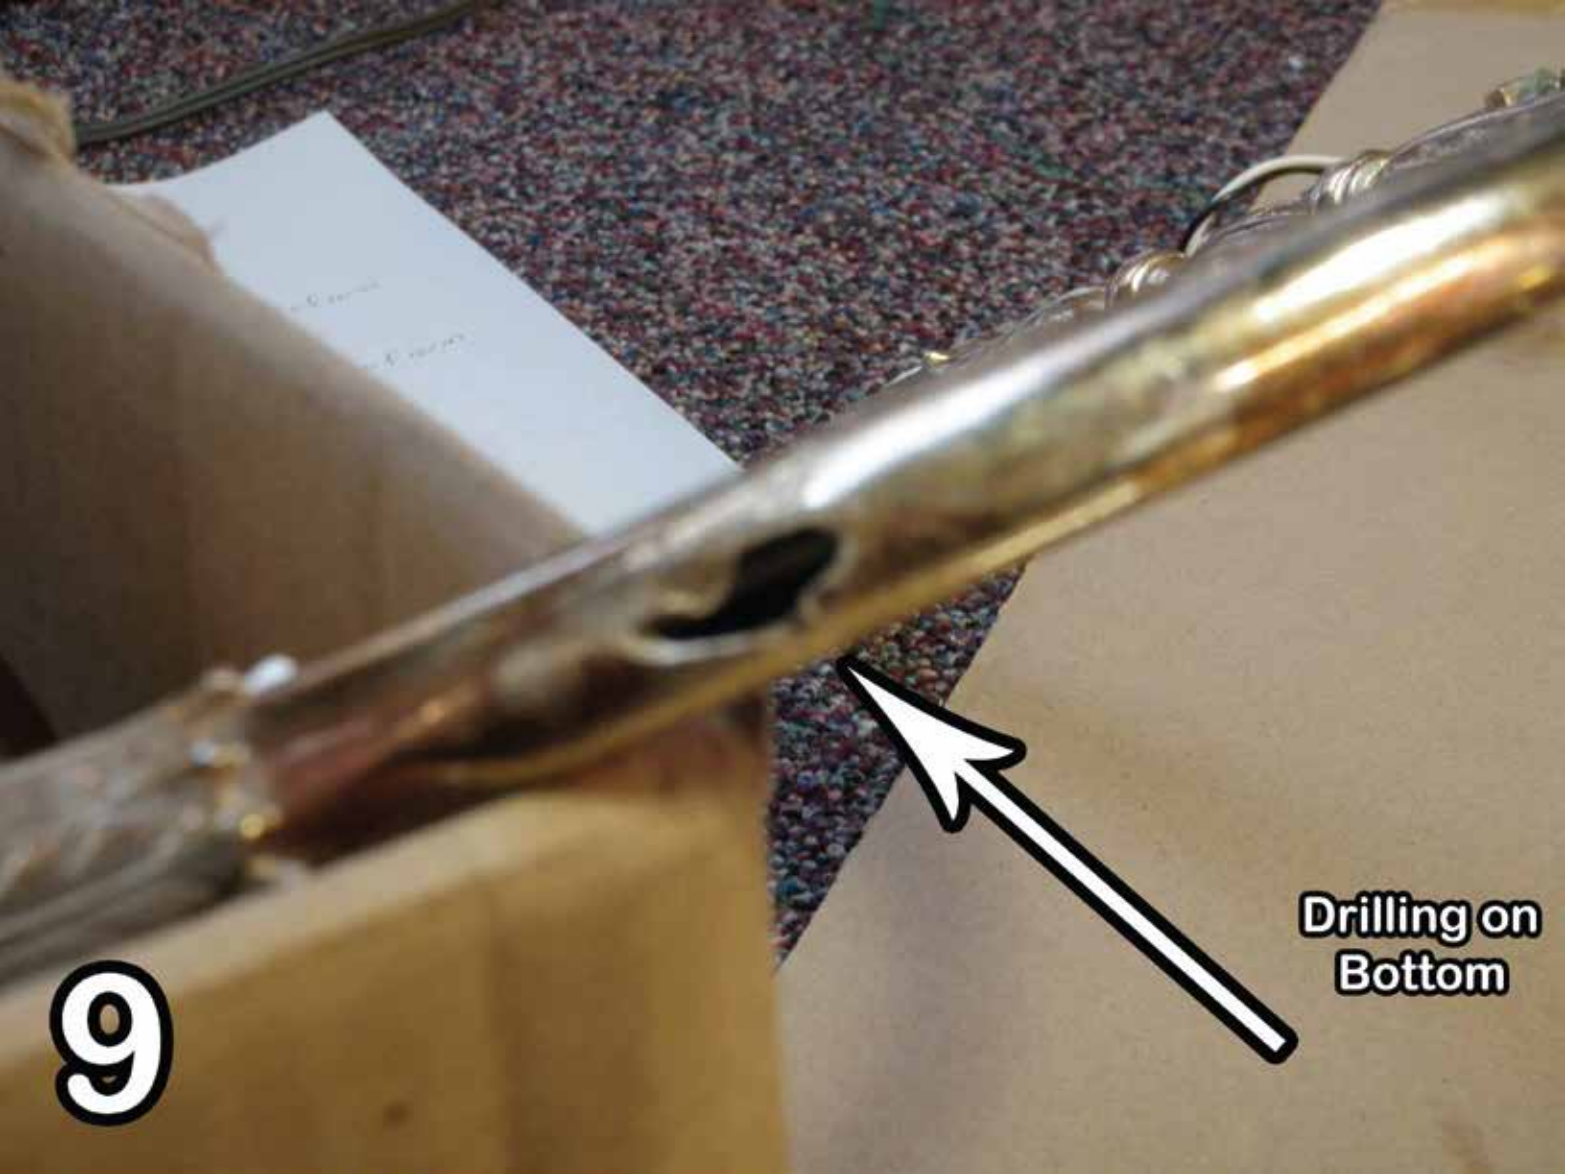
- Arm #9 has three previously drilled holes on the top and one on the bottom.
- This damage will not be repaired as it can cause further damage to the arm and the plating. A protective sleeve will be added on wire to protect it.

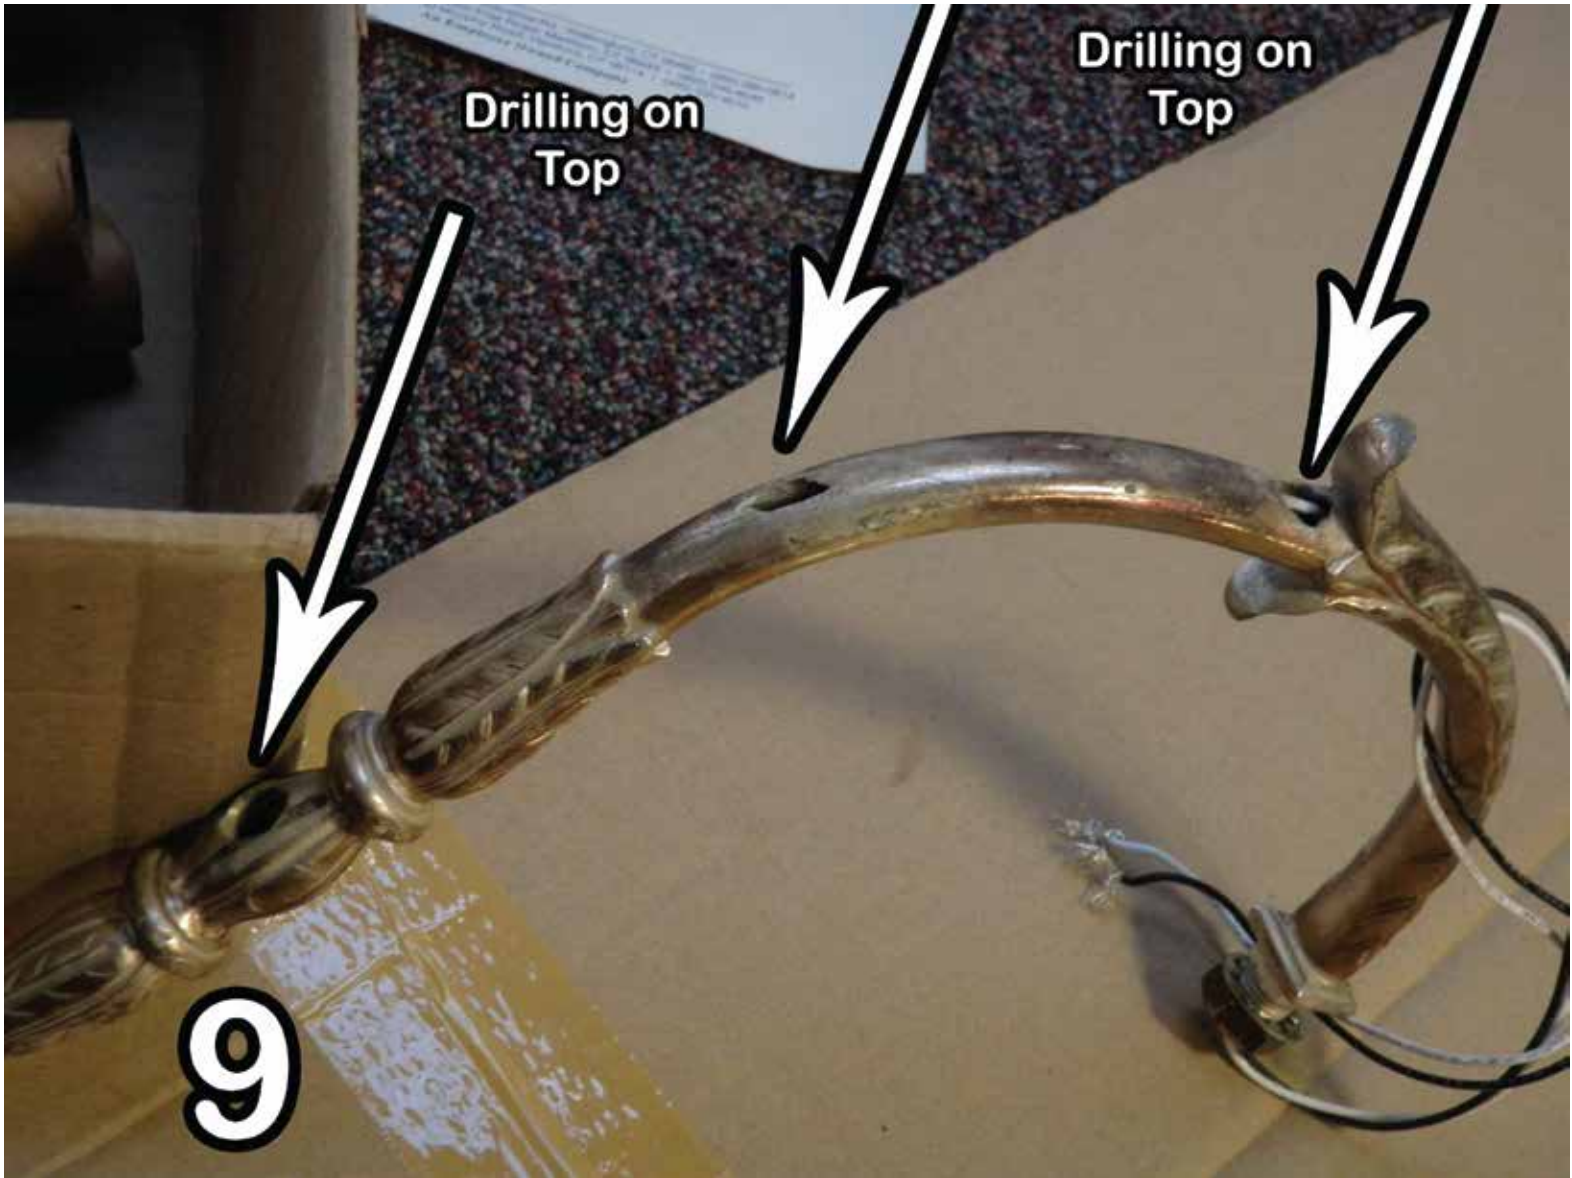
- Arm #9 has three previously drilled holes on the top and one on the bottom.
- This damage will not be repaired as it can cause further damage to the arm and the plating. A protective sleeve will be added on wire to protect it.

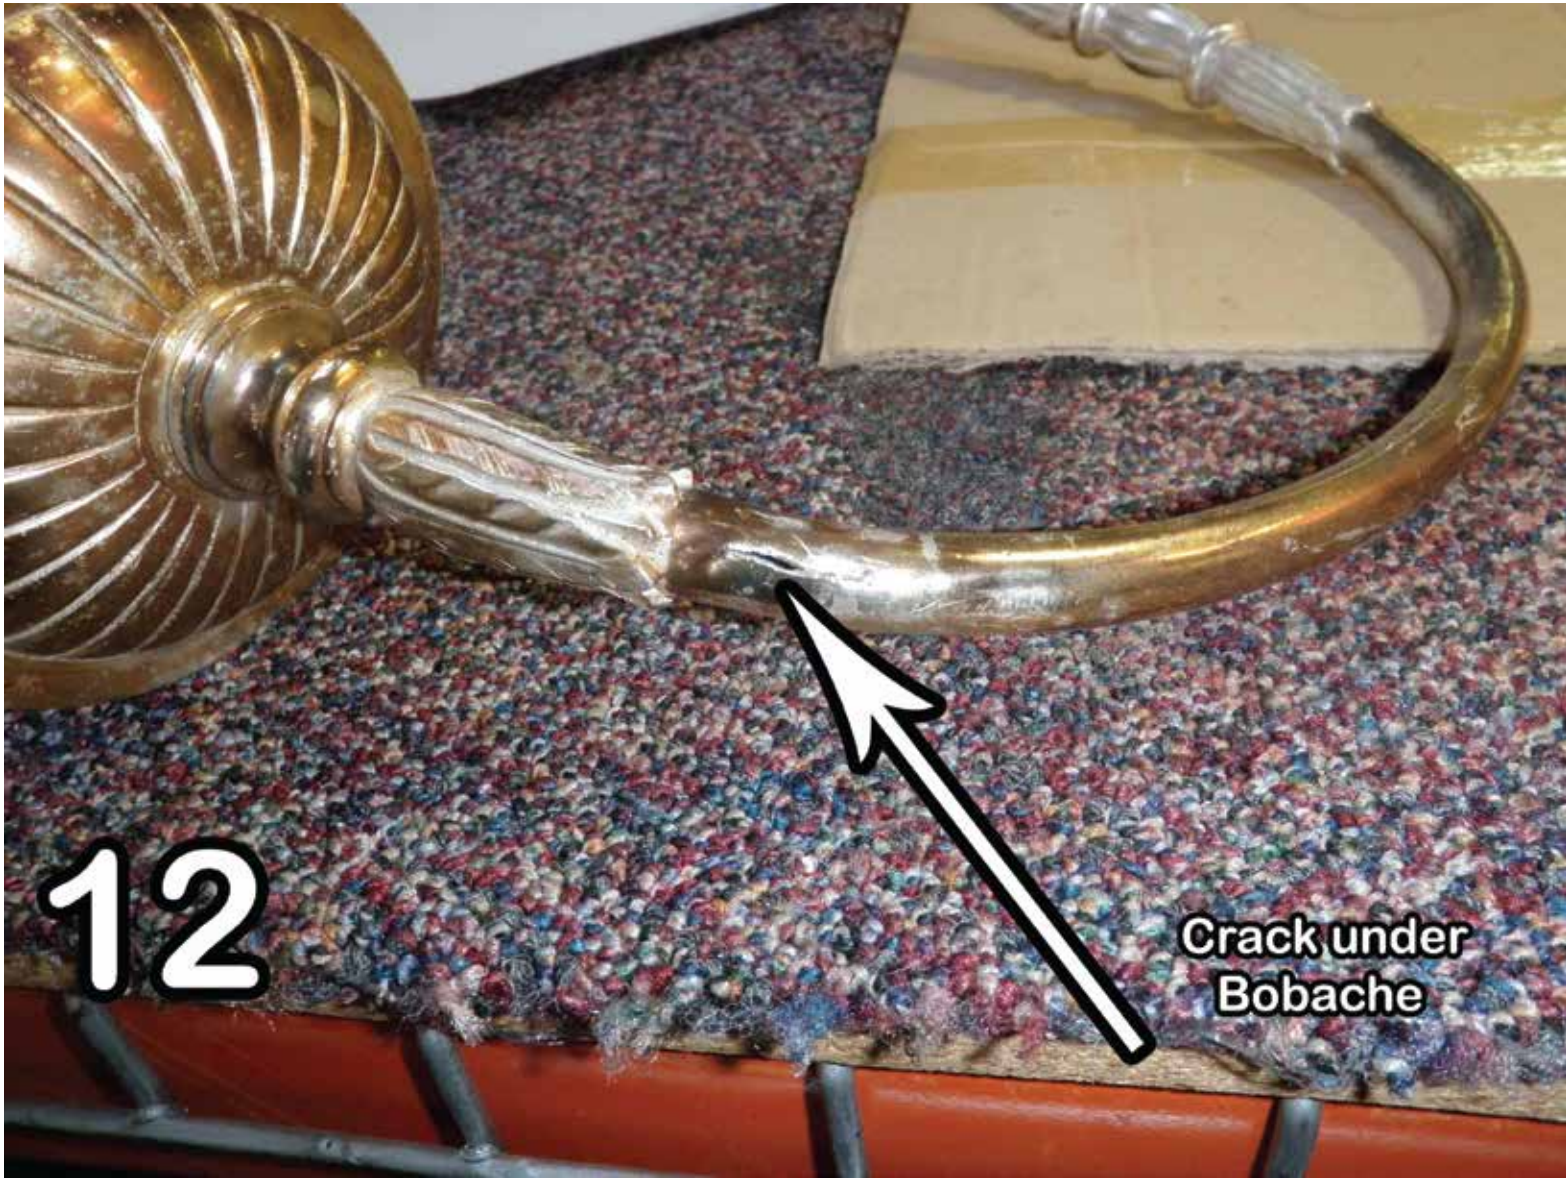
- Arm # 12 has one crack under the bobache.
- This damage will not be repaired as it can cause further damage to the arm and the plating. A protective sleeve will be added on wire to protect it.
