Sagamore Hill National Historic Site

TYPE: 89

- Electrified Wall Bracket

Project: Sagamore Hill National Historic Site

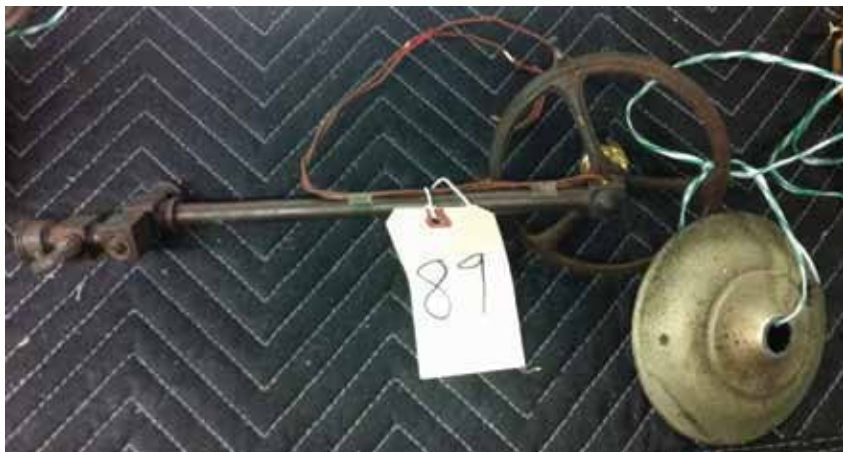
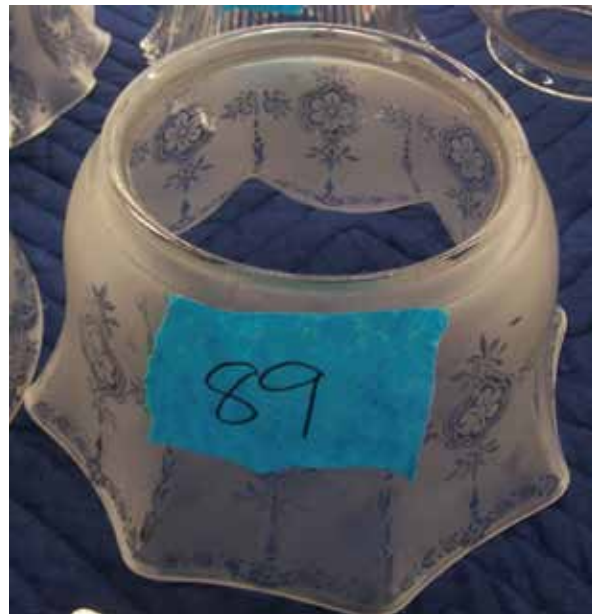
(Pre-Restoration)

- Sewing Room 310

- Frame: #89 SAHI 7334A

- Clean/Walnut blast to remove excess corrosion, apply brass rub and patina as required to blend to existing finish, application of museum grade wax.
- Glass 49 cracked, crack to be repaired.
- Clean glass shield to remove any surface residue.
- No replacement glass.
- Replace and rewire all electrical components with UL listed products and test in accordance with UL standards.
- Provide new escutcheon. (see attached cutsheet)

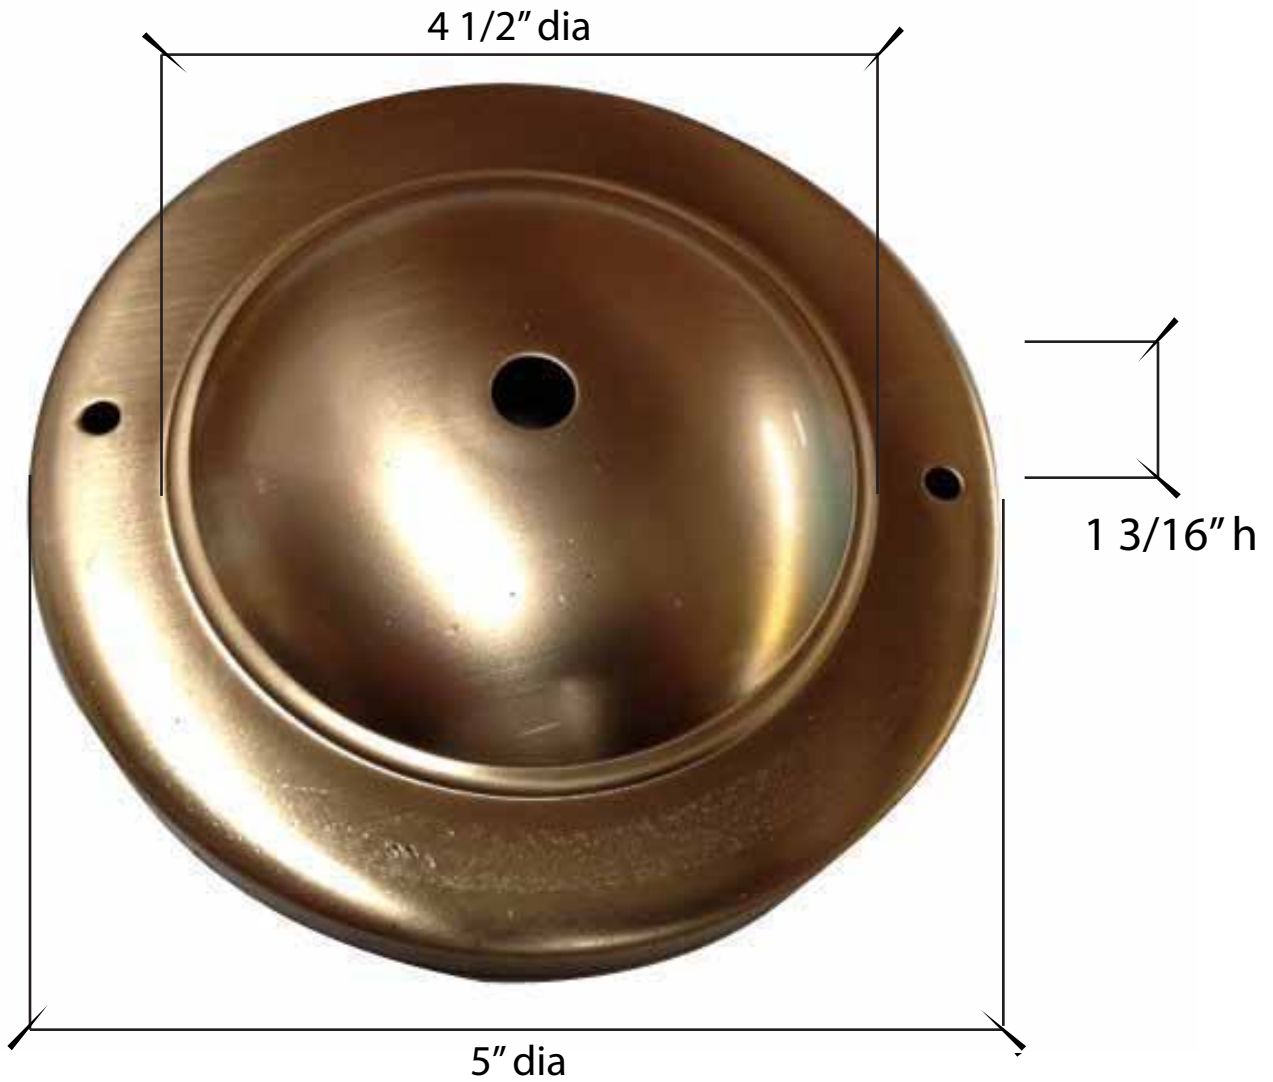
Escutcheon Concept

- Stamped Brass Escutcheon
- Finish to closely match existing finish
