Sagamore Hill National Historic Site

TYPE: 58-59

- Double Guest Room 208

Project: Sagamore Hill National Historic Site

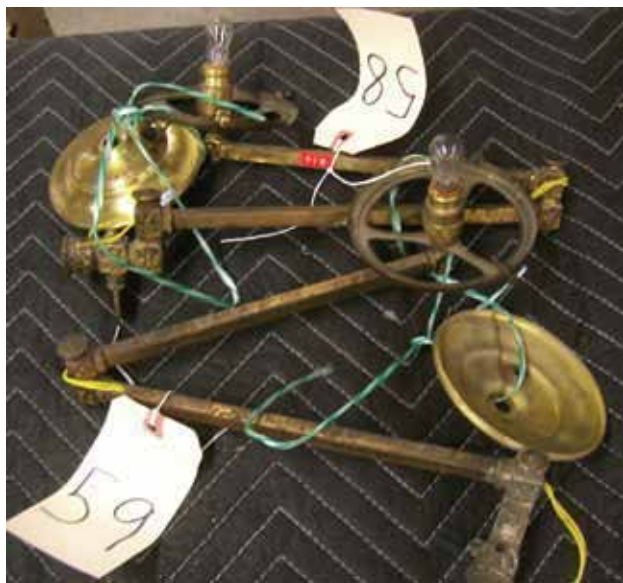
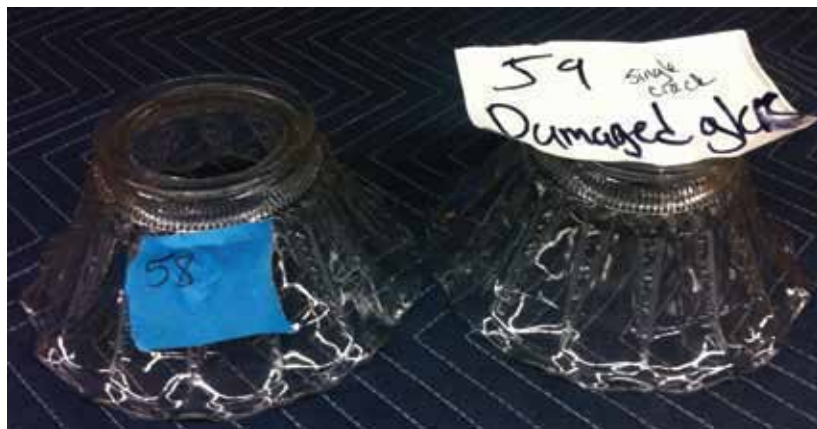
(Pre-Restoration)

- Electrified Wall Bracket

- Clean/Walnut blast to remove excess corrosion, apply brass rub and patina as required to blend to existing finish, application of museum grade wax
- Glass 59 cracked, crack to be repaired.
- Clean glass shield to remove any surface residue.
- No replacement glass.
- Replace and rewire all electrical components with UL listed products and test in accordance with UL standards.
- New custom wall escutcheon. (Solder existing to new code compliant escutcheon)
(see attached cutsheet)

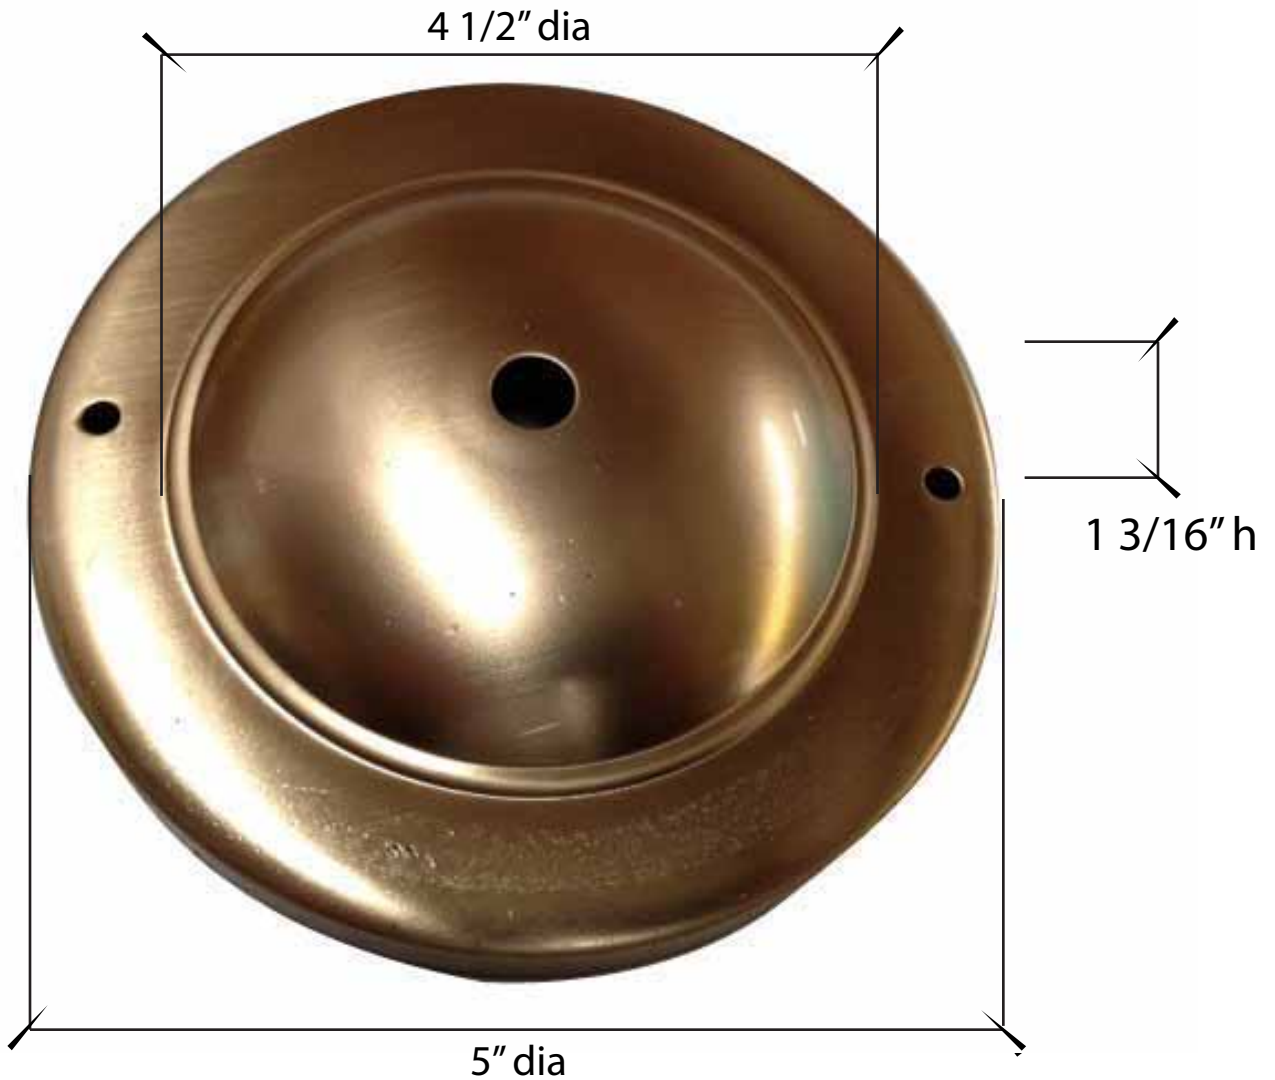
Escutcheon Concept

- Stamped Brass Escutcheon
- Finish to closely match existing finish
