# 1001 5th Ave - Exterior Lanterns

## Project: 1001 5th Ave - Exterior Lanterns

S/O #: 71933

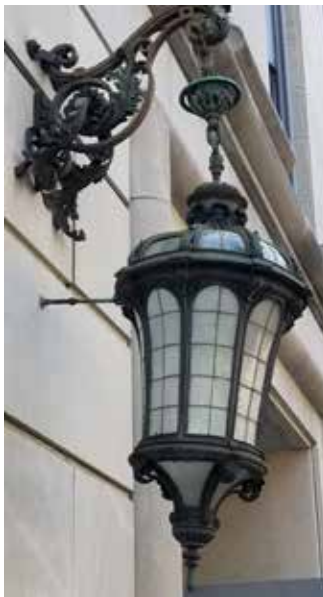
(Pre-Restoration)

**Description:** Exterior Lantern

**Location:** Front of Building

- Fixture to be cleaned/walnut blasted, apply patina as required to blend existing finish, application of a UV resistant lacquer to all metal surfaces. The fixture has existing blemishes that we will work to minimize, but in many cases, will remain.

- Ultrasonically and hand clean existing diffusers. Reinforce all weak copper foil, solder, and antique to blend with existing.
- Repair the top of (1) lantern where it has separated and all other mechanical defects including threaded rods nipples, etc.

- Replace and rewire all electrical components with UL listed products and test in accordance with UL standards. Mogul base socket to be utilized.
- 12" lead to be supplied at the end of the fixture.

- All anchorage, i.e mounting bolts to be provided by others. Grand Light will patina/paint them to match the finish.
- (8) replacement slumped glass panels on top of lantern. A close match will be provided.

- (2) steel brackets refinished with a satin black.
- Replace (7) damaged upper slumped panels, (1) damaged mid section panel, and (1) damaged bottom slumped panel.
