## Property History

## Project Description

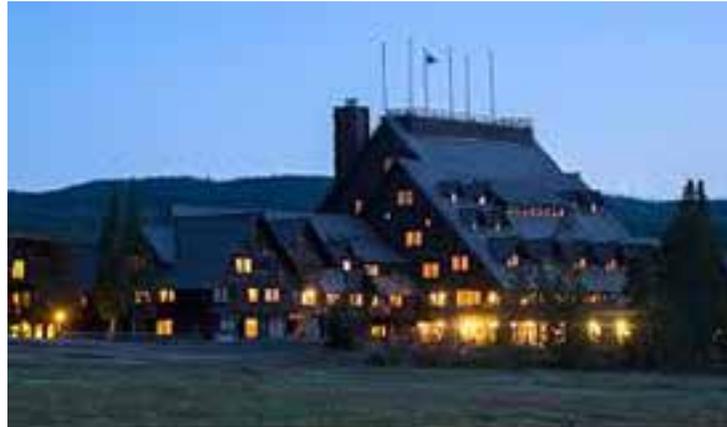
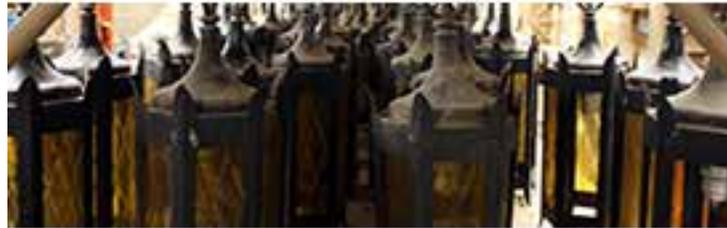
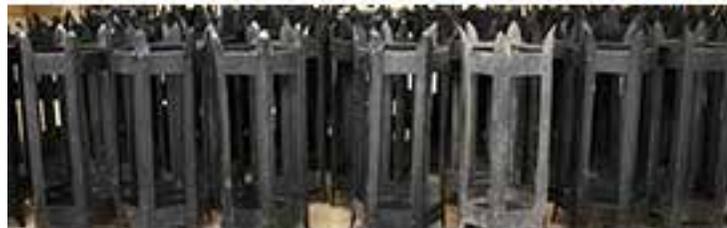
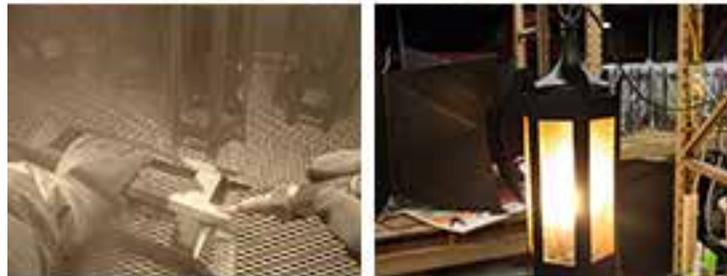
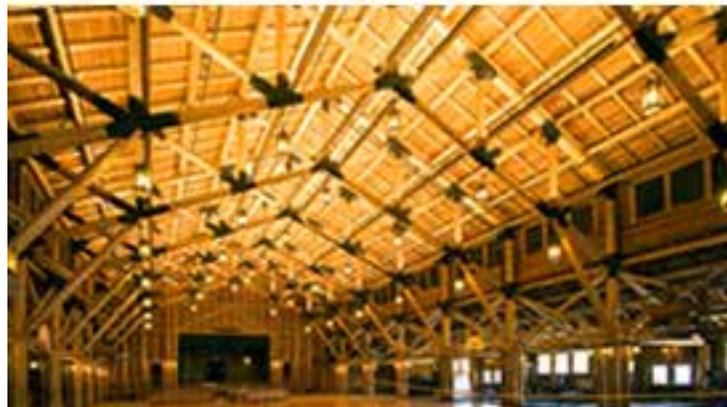
All structural repairs and replications of missing or damaged components were completed as a first step in the restoration project. The twisted and bent spears at the top and bottom of the fixture were straightened back to their original shape. Frames that were bent were reshaped, and missing rivets were replicated and attached to the fixtures.

Many fixtures were missing tabs that were meant to hold the glass panels. As a previous fix to this problem, some panels had been siliconed to the frame as a temporary solution. This silicone was removed and new tabs were fabricated and soldered to the fixture.

Following a site visit earlier in the year, Grand Light was selected to restore and replicate the lighting fixtures from the historic Geyser Hall. Rather than risk loss or damage in transit via a common carrier, Grand Light returned to Geyser Hall and carefully packed and transported the historic fixtures 2,400 miles back to Connecticut. These fixtures included 148 gothic-style pendant luminaires, of which 28 were replicated, as well as 40 larger luminaires of the same style. Grand Light refinished all luminaire components, inspected and repaired all mechanical defects, replaced all existing electrical components with UL listed products, rewired and HIPOT tested the fixtures. To restore the historical integrity of the luminaires, previously installed plastic panels were replaced with historically accurate medium-amber glass.
