Trinity United Methodist Church

Type: A

Description: Chandelier

Project: Trinity United Methodist Church

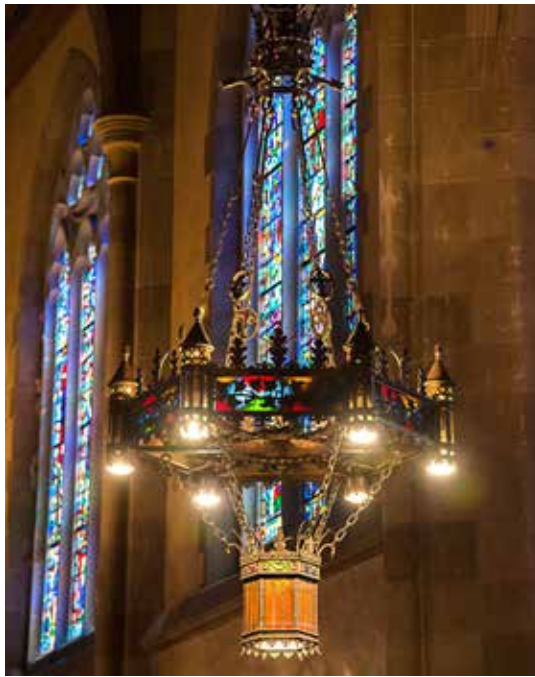
(Typical Pre-Restoration Photograph)

Location: Nave

Lights: 25

- Existing fixture shall be disassembled, ultrasonically and/or hand cleaned, and walnut or soda blasted to prepare the existing raw steel surface. Application of UV resistant protective metal oil top coating.
- Replace and rewire all electrical components with UL listed products and test in accordance with UL 1598 standards. UL label on all fixtures. Medium base sockets to be utilized.
- Fabricate (36) new upper amber mica diffusers.
- Replace (36) bottom amber theatrical gel on plastic diffusers with (36) mica panels to match upper mica diffusers.
- Fabricate (1) missing lower lamp access door and finish to match.
- Add a reflector into crown of outer lampholder. Relocate socket 1 1/8" from original location for diffuse down lighting.
