**The Jewish Center
Type: 1**

Historic Lighting Restoration & Custom Lighting

Project: The Jewish Center

QTY: 6 VOL: FINAL Date: 7/22/19 Type: 1

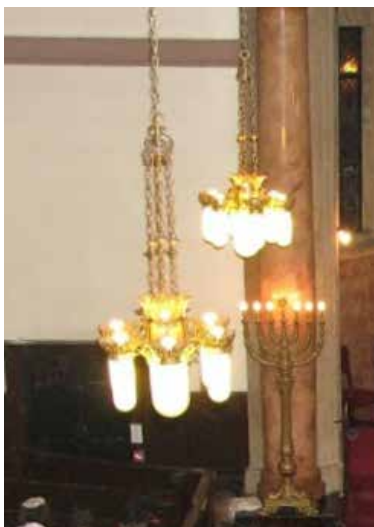
(Typical Pre-Restoration Photograph)

Description: Chandelier

Lights: 13 (6 Uplights & 7 Downlights)

- Existing fixture shall be disassembled, all paint is removed from steel components and conserve the original steel finish. Application of UV resistant protective top coating of lacquer.
- Remove gold painted finish from all brass components and apply an antique brass patina with burnished highlights. Apply a UV resistant lacquer topcoat.
- Replace (36) opal glass diffusers with new opal glass diffusers on chandelier arms. (Type B Dimensions: 4-7/8" x 10-3/8" x 4-5/8")
- Replace (6) opal glass diffusers with new opal glass diffusers on bottom of chandelier. (Type A Dimensions: 8" x 16" x 8")
- Replace and rewire all electrical components with UL listed products and test in accordance with UL 1598 standards. UL label on all fixtures. Medium base sockets to be utilized.
- Repair all mechanical defects to glass fitters.
- Replace all glass set screws.

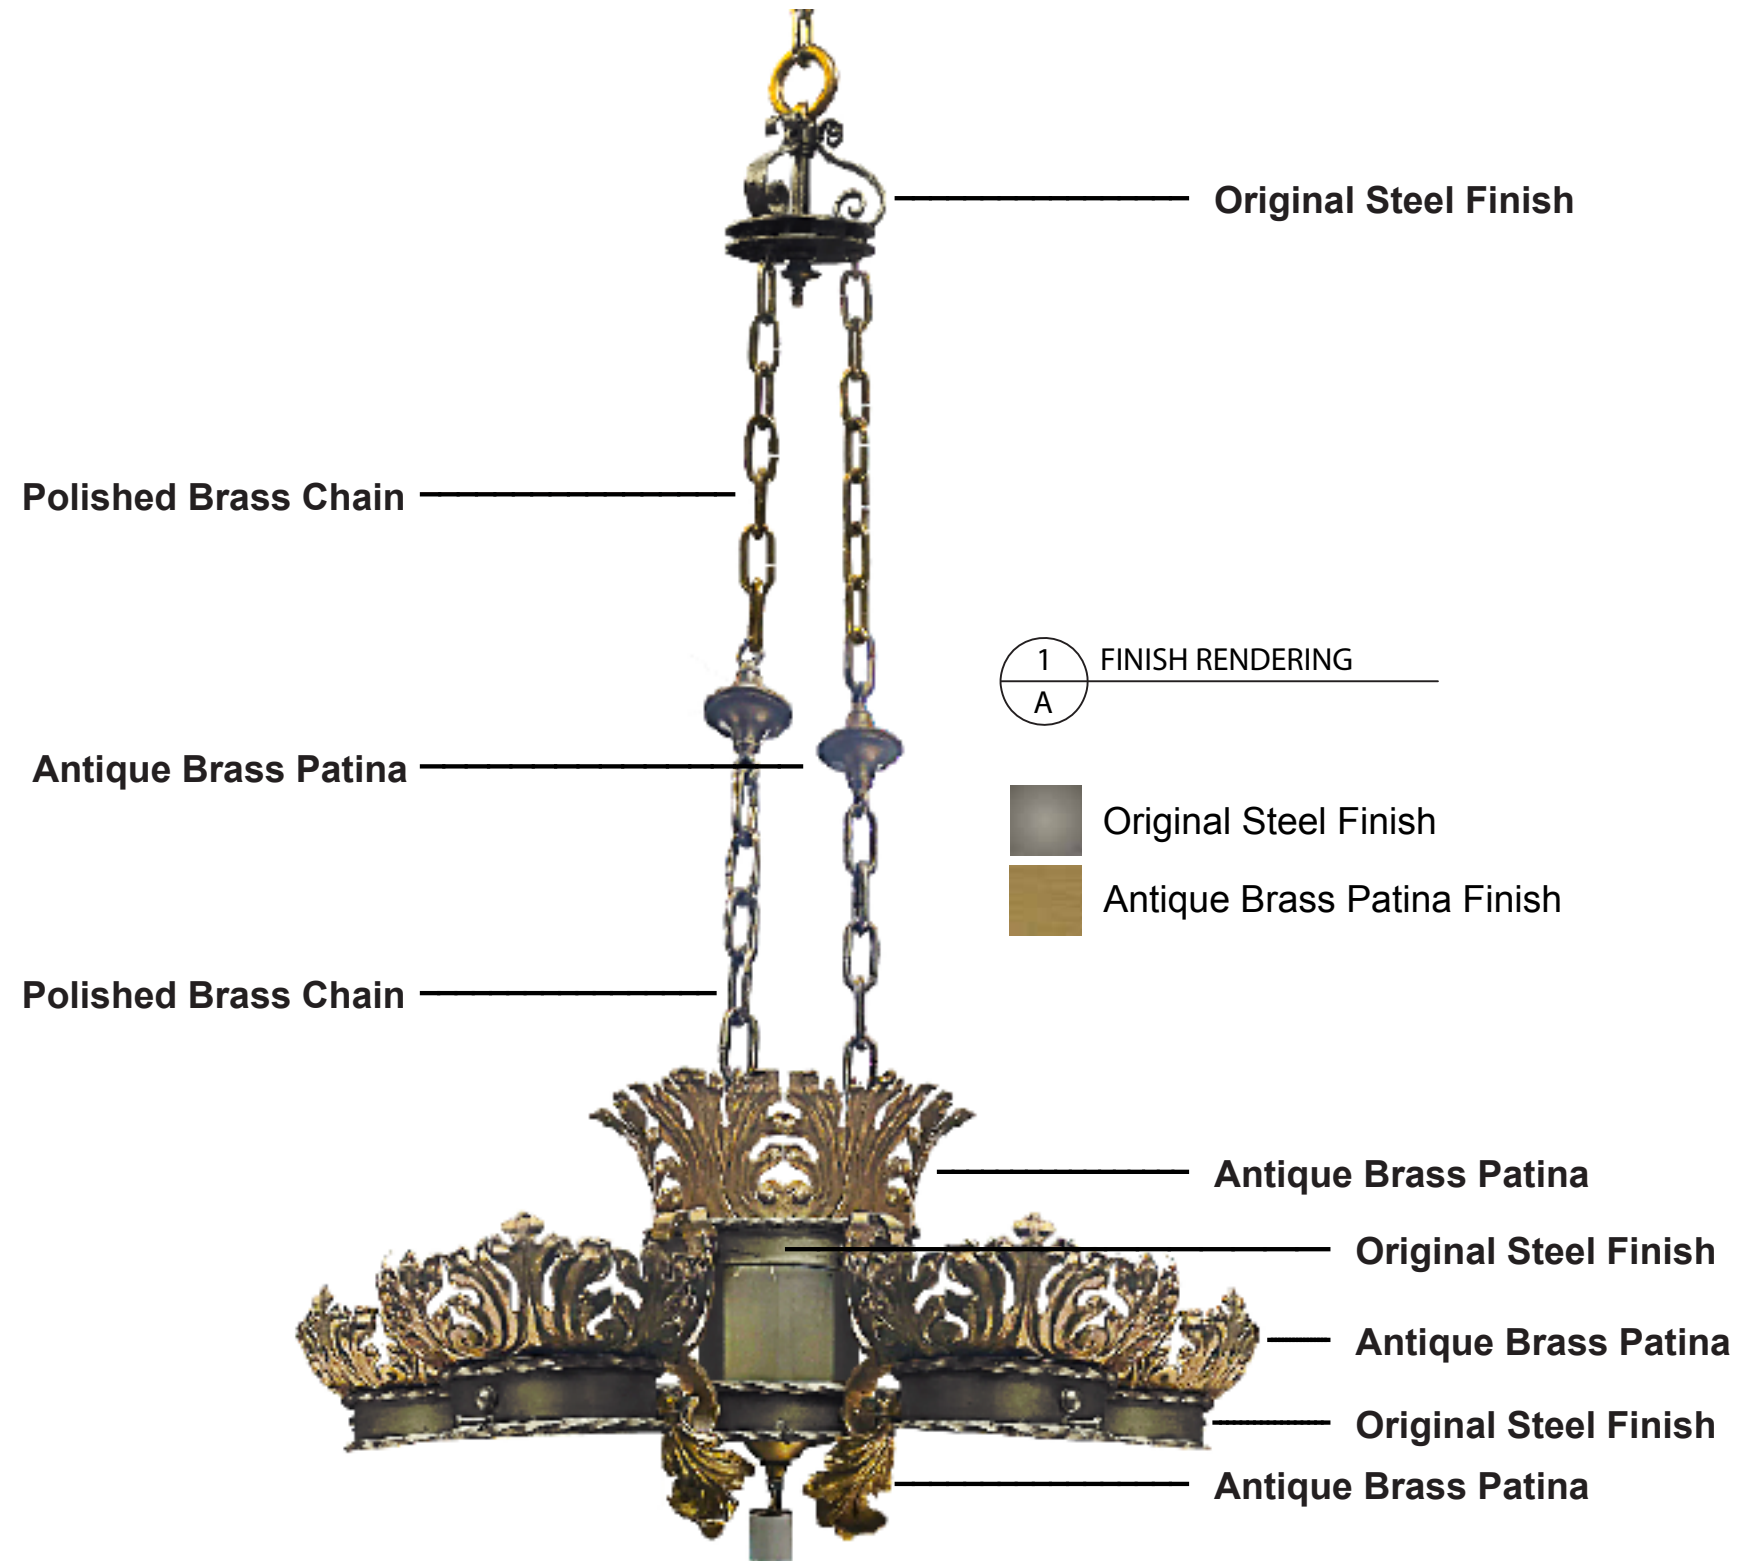
The Jewish Center
Type: 1

Lamp: TBD	Socket: (13) Medium	S/O #: 72161
Finish: Brass/Gold	Circuits: 1	Glass: Opal
Voltage: 120v	Material: Brass/Steel	Type: Indoor
